# Analysis of medical evacuation following the Tünektepe cable car accident in Turkey in 2024

**Background:** The Tünektepe Touristic Cable Car accident happened on 12 April 2024, when a support pole collapsed, causing the nearest cabin to crash to the ground. One cabin fell to the ground, while 35 others were left suspended in the air. This study aims to analyze the demographic characteristics and medical conditions of the 182 victims of the accident. **Methods:** Transportation records and other related documents were analyzed retrospectively. The demographic data, clinical symptoms, Injury Severity Scores (ISS), medications administered, and prognoses of the accident victims were examined separately. **Results:** Rescue efforts lasted 23 hours, and the mean age of the victims was 32 years. One person (0.54%) died at the scene, 20 people (11%) sustained injuries, and 161 people (89%) were asymptomatic. The fatality was attributed to severe head and neck trauma. Among the rescued patients, 14 (7.7%) sustained extremity injuries. ISS distribution was as follows: nine patients (43%) scored 1, four (19%) scored 4, two (9.5%) scored 13, two (9.5%) scored 10, one (4.7%) scored 50, one

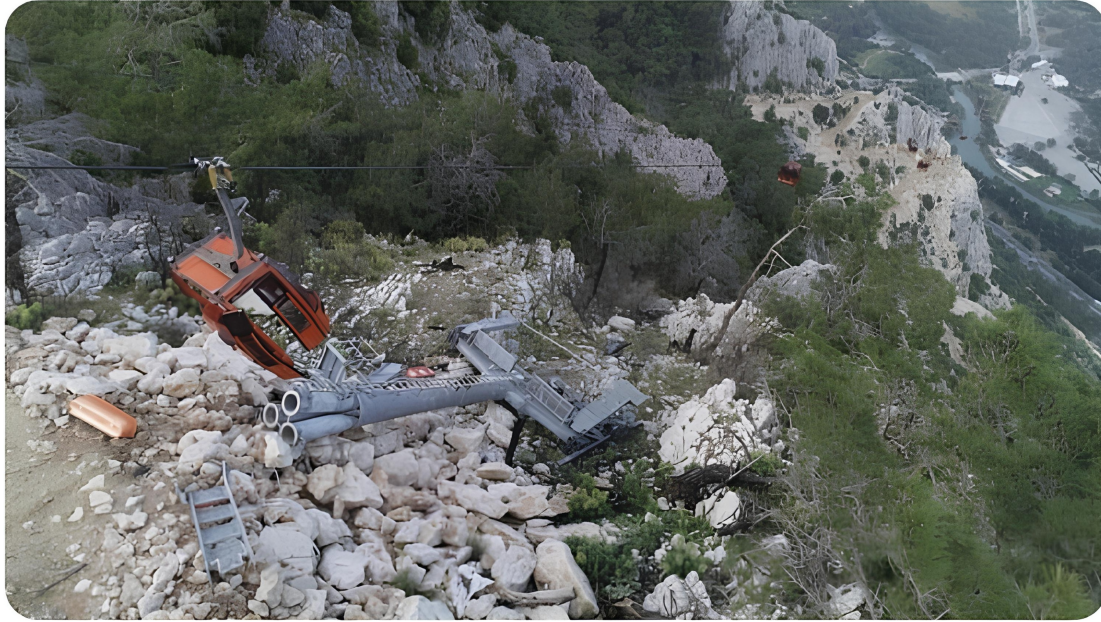
**FIGURE 1.** Image of broken cable car pole and falling wagon.

On 12 April 2024, at 17:28, one of the cable car poles collapsed and struck one of the cabins. Eight passengers inside the cabin fell approximately 20 meters onto the rocky terrain. As a result, one person died and seven others, including two children, were injured at the scene. An additional three individuals sustained injuries during the rescue operation. In total, 174 passengers stranded in midair were rescued over the course of 23 hours [2] (Fig. 1).

A 52-page expert report was prepared following the investigation. According to the report, the accident occurred because one of the 10 pulleys on pole number 5 (return side to Tünektepe station) broke, yet the system continued to operate. The pole, unable to withstand the sudden pulling force, fractured at its midpoint. When the pole collapsed, it snapped downward and struck the nearest cabin, causing the cabin to crash to the ground. The cabin first hit the top of the tower, shattering its windows. Immediately after the impact, the cabin separated from the rope and fell about 20 meters [3]. Upon impact, the cabin shattered at the base. As a result, the eight passengers inside the cabin suffered trauma from both being thrown and from the vertical fall to the ground.

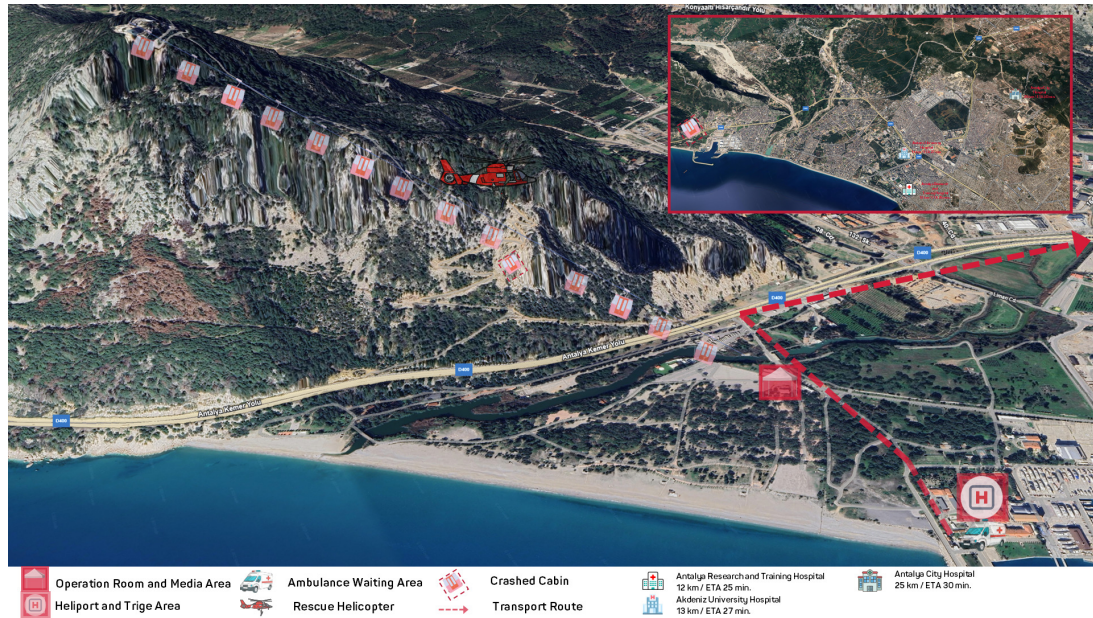
**FIGURE 2.** The sketch of rescue setup and scene management.

**Tower-Based Rescue:** Victims in cabins near the poles were evacuated by installing ladders on the poles, climbing to the top, breaking the cabin door, and removing passengers one by one. Each victim was secured with a full-body belt and lowered vertically using rope systems. Side guards, backup fall arresters, and intermediate anchors were used for additional safety.

**On-Line Rescue:** Firefighters used a rescue trolley running on the towing rope. Rescuers climbed the poles, installed the trolley, and approached the cabins. Cabins could not be opened from inside, so temporary anchors were installed, and victims were secured with full-body belts before being lowered to the ground via a twin-tension system. Care was taken to minimize

transferred by ground ambulance to the nearest trauma centers (Fig. 2).
