ORIGINAL RESEARCH

Analysis of medical evacuation following the Tünektepe cable car accident in Turkey in 2024

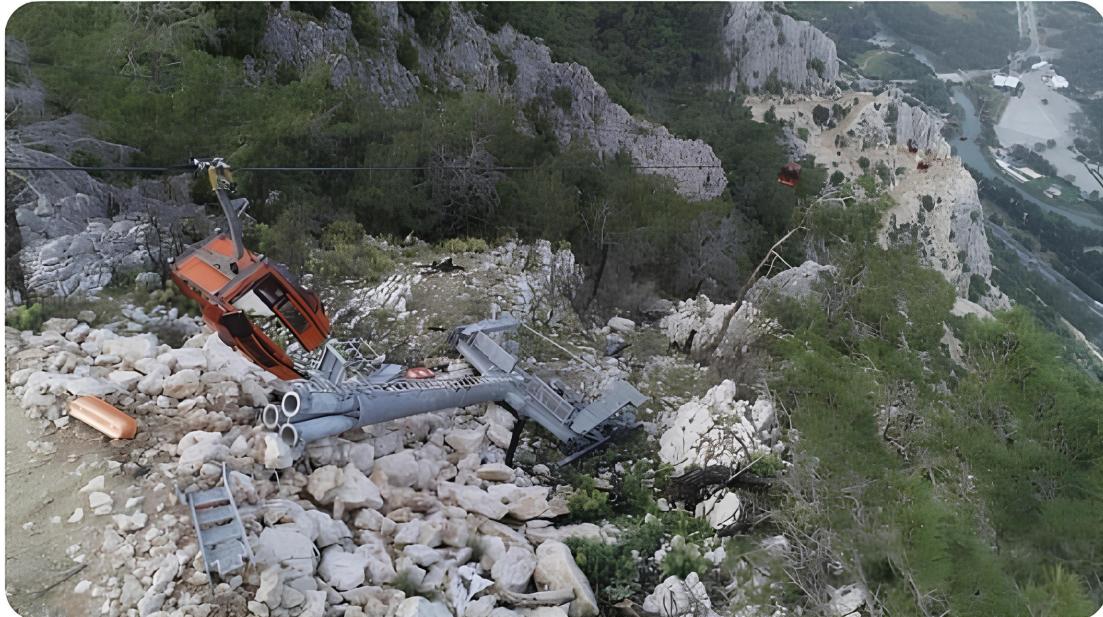
FIGURE 1. Image of broken cable car pole and falling wagon.

On 12 April 2024, at 17:28, one of the cable car poles collapsed and struck one of the cabins. Eight passengers inside the cabin fell approximately 20 meters onto the rocky terrain. As a result, one person died and seven others, including two children, were injured at the scene. An additional three individuals sustained injuries during the rescue operation. In total, 174 passengers stranded in midair were rescued over the course of 23 hours [2] (Fig. 1).

A 52-page expert report was prepared following the investigation. According to the report, the accident occurred because one of the 10 pulleys on pole number 5 (return side to Tünktepe station) broke, yet the system continued to operate. The pole, unable to withstand the sudden pulling force, fractured at its midpoint. When the pole collapsed, it snapped downward and struck the nearest cabin, causing the cabin to crash to the ground. The cabin first hit the top of the tower, shattering its windows. Immediately after the impact, the cabin separated from the rope and fell about 20 meters [3]. Upon impact, the cabin shattered at the base. As a result, the eight passengers inside the cabin suffered trauma from both being thrown and from the vertical fall to the ground.

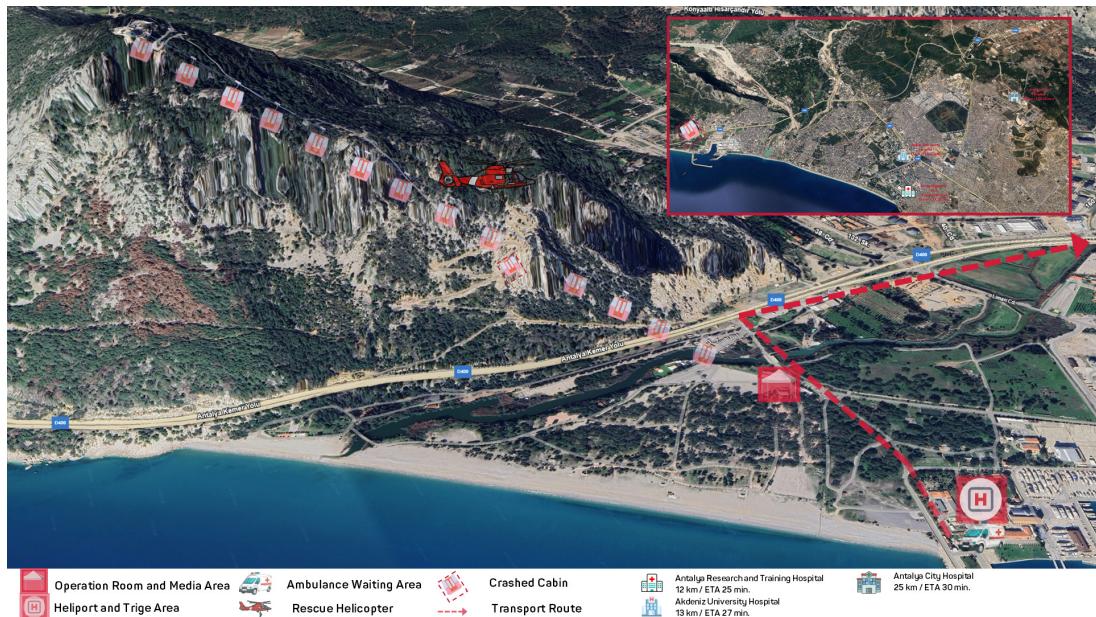
FIGURE 2. The sketch of rescue setup and scene management.

Tower-Based Rescue: Victims in cabins near the poles were evacuated by installing ladders on the poles, climbing to the top, breaking the cabin door, and removing passengers one by one. Each victim was secured with a full-body belt and lowered vertically using rope systems. Side guards, backup fall arresters, and intermediate anchors were used for additional safety.

On-Line Rescue: Firefighters used a rescue trolley running on the towing rope. Rescuers climbed the poles, installed the trolley, and approached the cabins. Cabins could not be opened from inside, so temporary anchors were installed, and victims were secured with full-body belts before being lowered to the ground via a twin-tension system. Care was taken to minimize

transferred by ground ambulance to the nearest trauma centers (Fig. 2).
