Unrecognized B line mimicked pneumothorax on M mode ultrasound

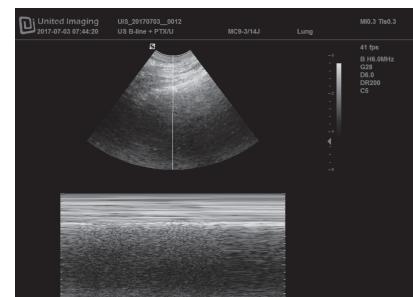
Figure 1. M mode image: "sea shore sign".

When the B line is not on the M mode cursor, the display shows a normal M mode ultrasound lung finding, termed the "sea shore" sign (figure 1). When the B line crosses the M mode cursor, BC is displayed (figure 2), and alterations of the "sea shore sign" and BC sign can easily be mistaken for a "lung point sign" (video clip).

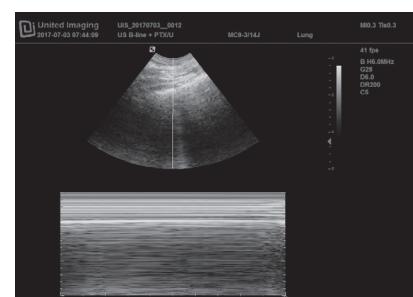
Figure 2. M mode image in the same patient: "bar code sign".

We present the images and a video clip with presentation of BC on M mode, caused by an (unrecognized) B line, mistakenly diagnosed as PNX. In this case, BC was caused by overlapping the unrecognized B line with the cursor (line) in M mode during respiratory movements in a mechanically ventilated patient.
